Revised submission Feb 06, 2023

Heritage and Land Use Report

Building and Site Redevelopment - 4 Merrymeeting Road, St. John's, NL

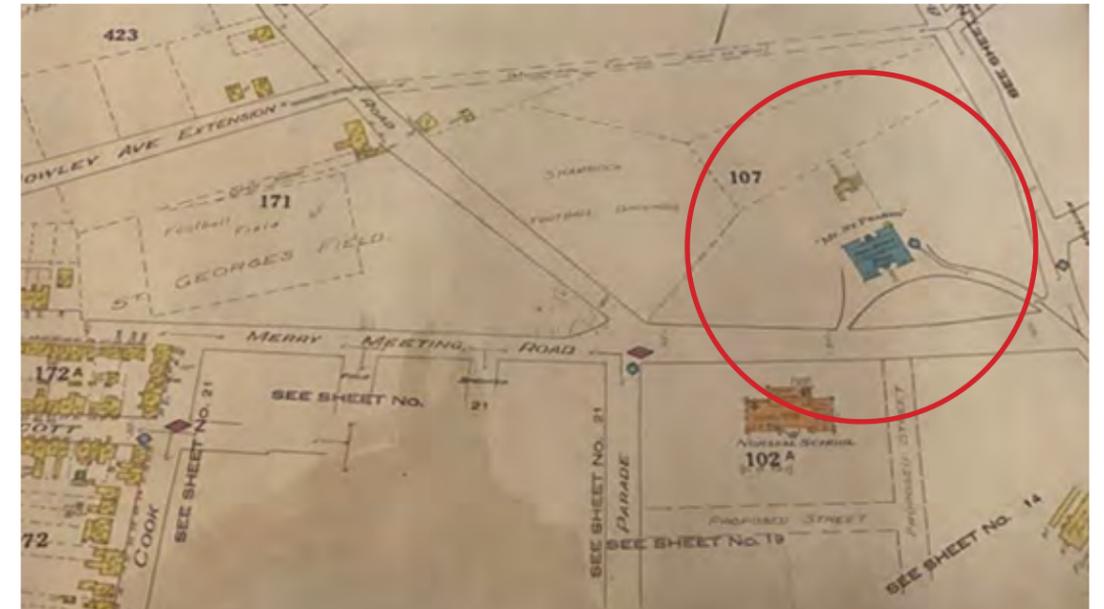
The property was first identified on the St. John's Insurance Plan in 1926.

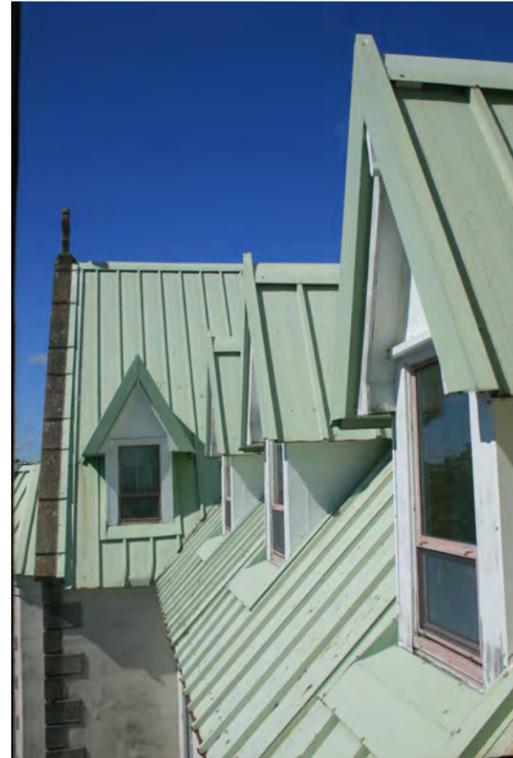
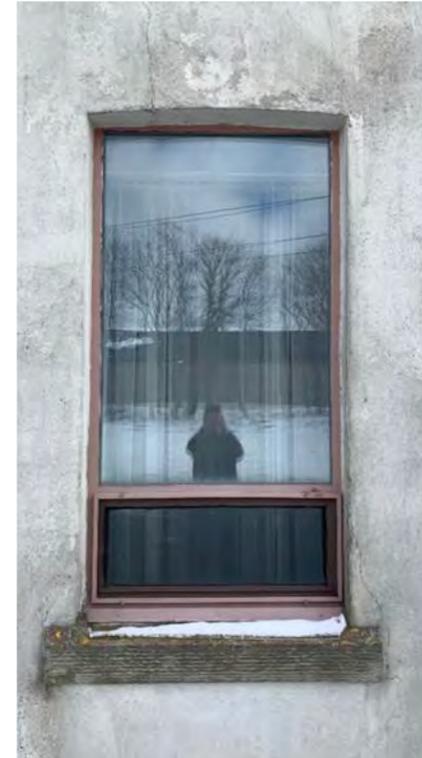
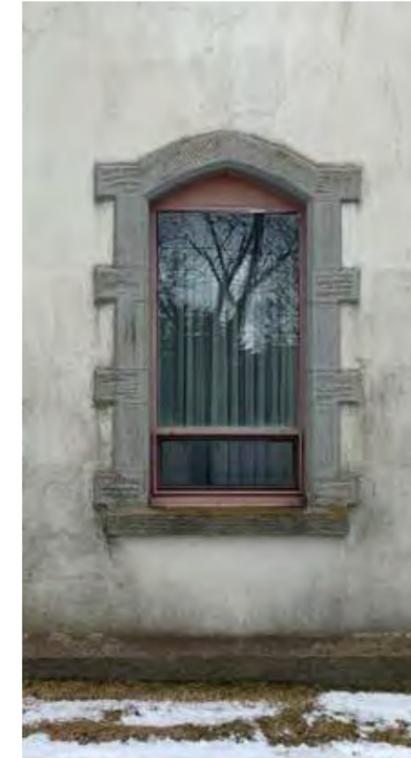
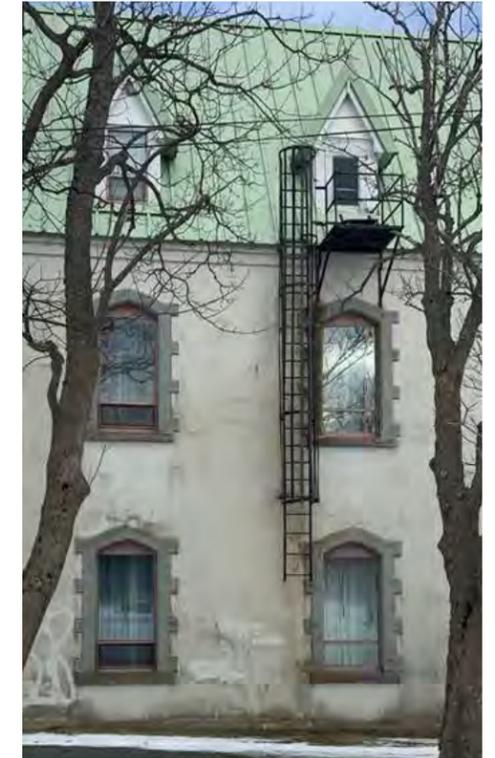
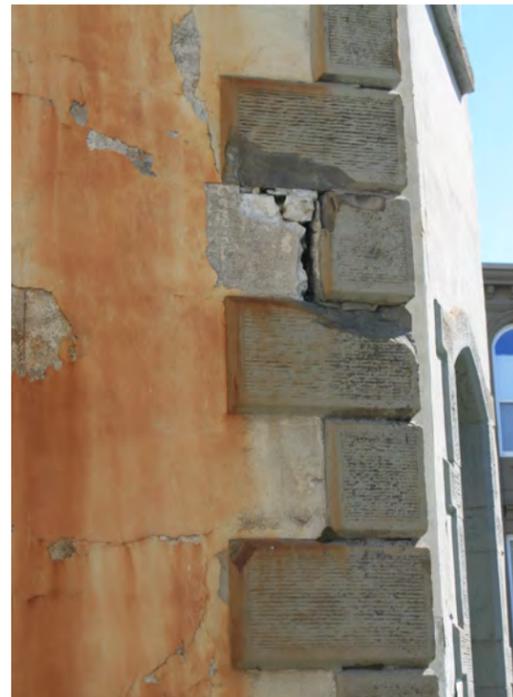
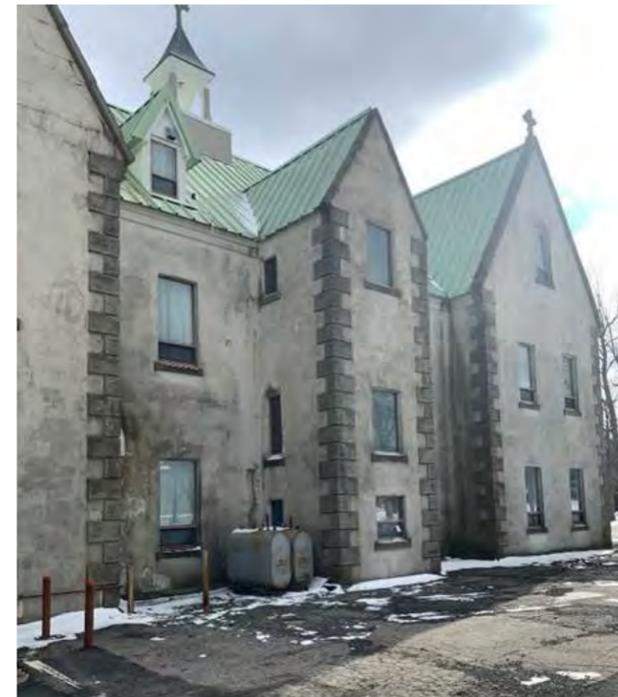
Exterior photos show:

- Parging on masonry/stone structure
- Masonry/stone quoins
- Standing Seam Metal roof
- Replacement windows
- Fire Escape

- Remove exterior surfaces: The existing exterior parging that has visually failed (spalling, etc) will be removed by a combination of hand tools and pressure washing, ensuring no damage to the substrate (brick). Any existing parging that remains bonded and in good condition will remain in place.
- Assess substrates in conjunction with interior removals
- Develop envelope strategy with objective of keeping exterior appearance

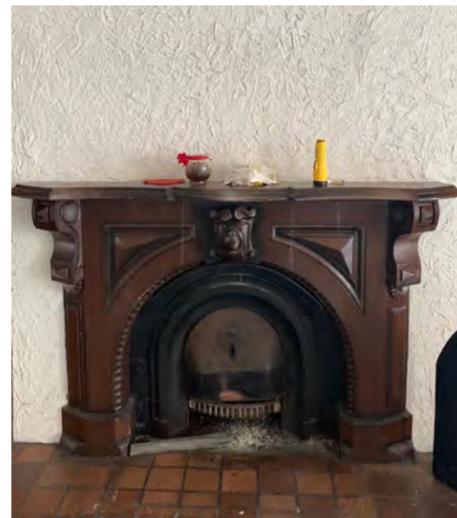
Wooden fireplace mantle

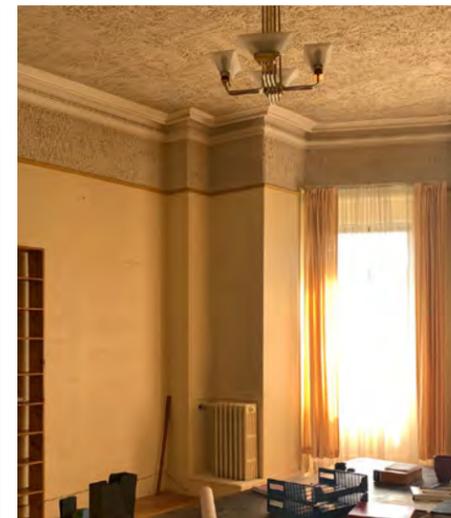
Decorative moldings and ceilings

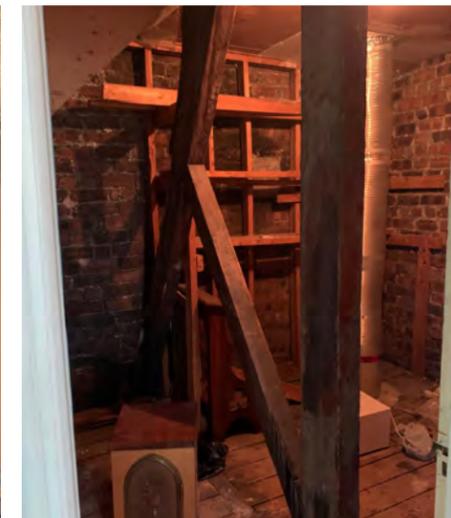
Heavy timber roof structure

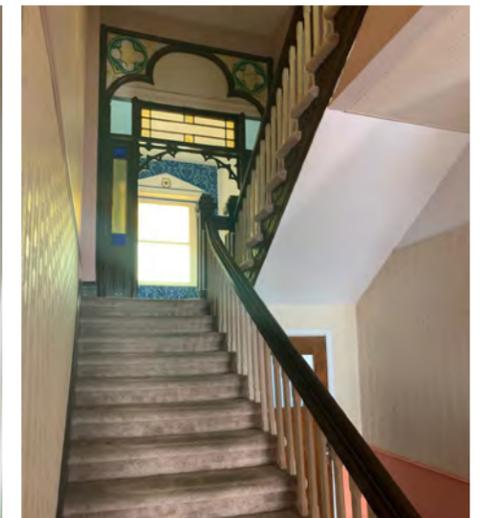
Main staircase

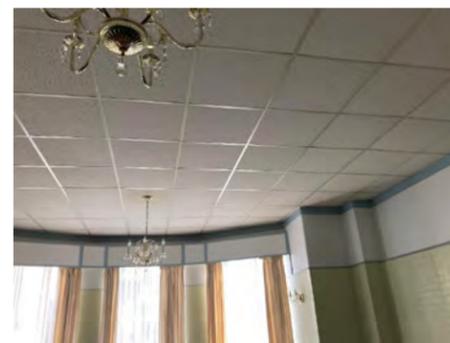
Typical drop ceiling over drywall or plaster

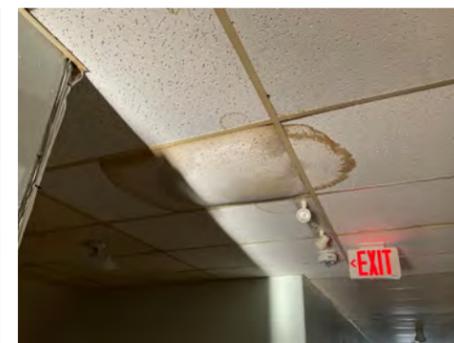
Fairly isolated occurrence of water damage

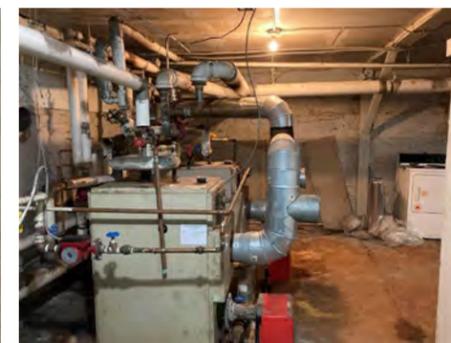
Furnace room in basement

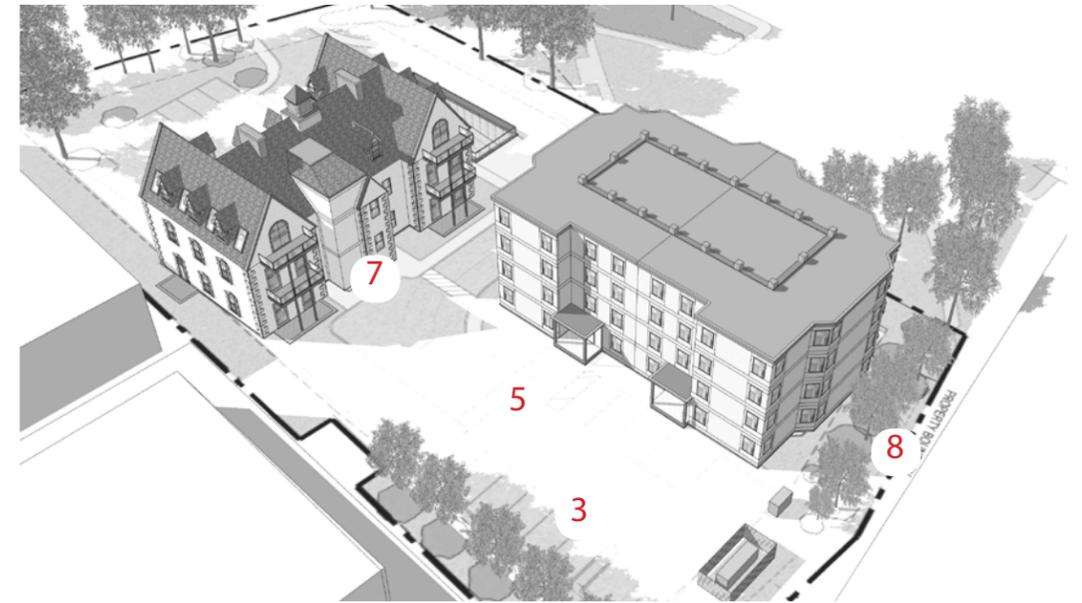
Legend

1. Monastery 6 Condominium Apartments
2. New Build 16 Condominium Apartments
3. Additional Surface Parking
4. Surface Parking
5. Under Ground Parking
6. Access to New Building and UG Parking
7. Access from UG Parking to Monastery
8. Maintain Pedestrian Route
9. Maintain Trees to Extent Practical

Emerald Park is composed of two interrelated components, the renovation of the Monastery into six condominium apartments, and a new building containing sixteen condominium apartments. The Monastery is well suited for this reuse, and the site comfortably accommodates the new building. Parking in excess of requirements is provided. This includes underground parking linked to the Monastery. Both buildings support each other in terms of function and project viability.

Site development includes some additional parking and landscaping. Trees not immediately impacted by the work will be protected. Existing pedestrian walkways will be maintained. The new building is located as far as possible away from Place Bonaventure.

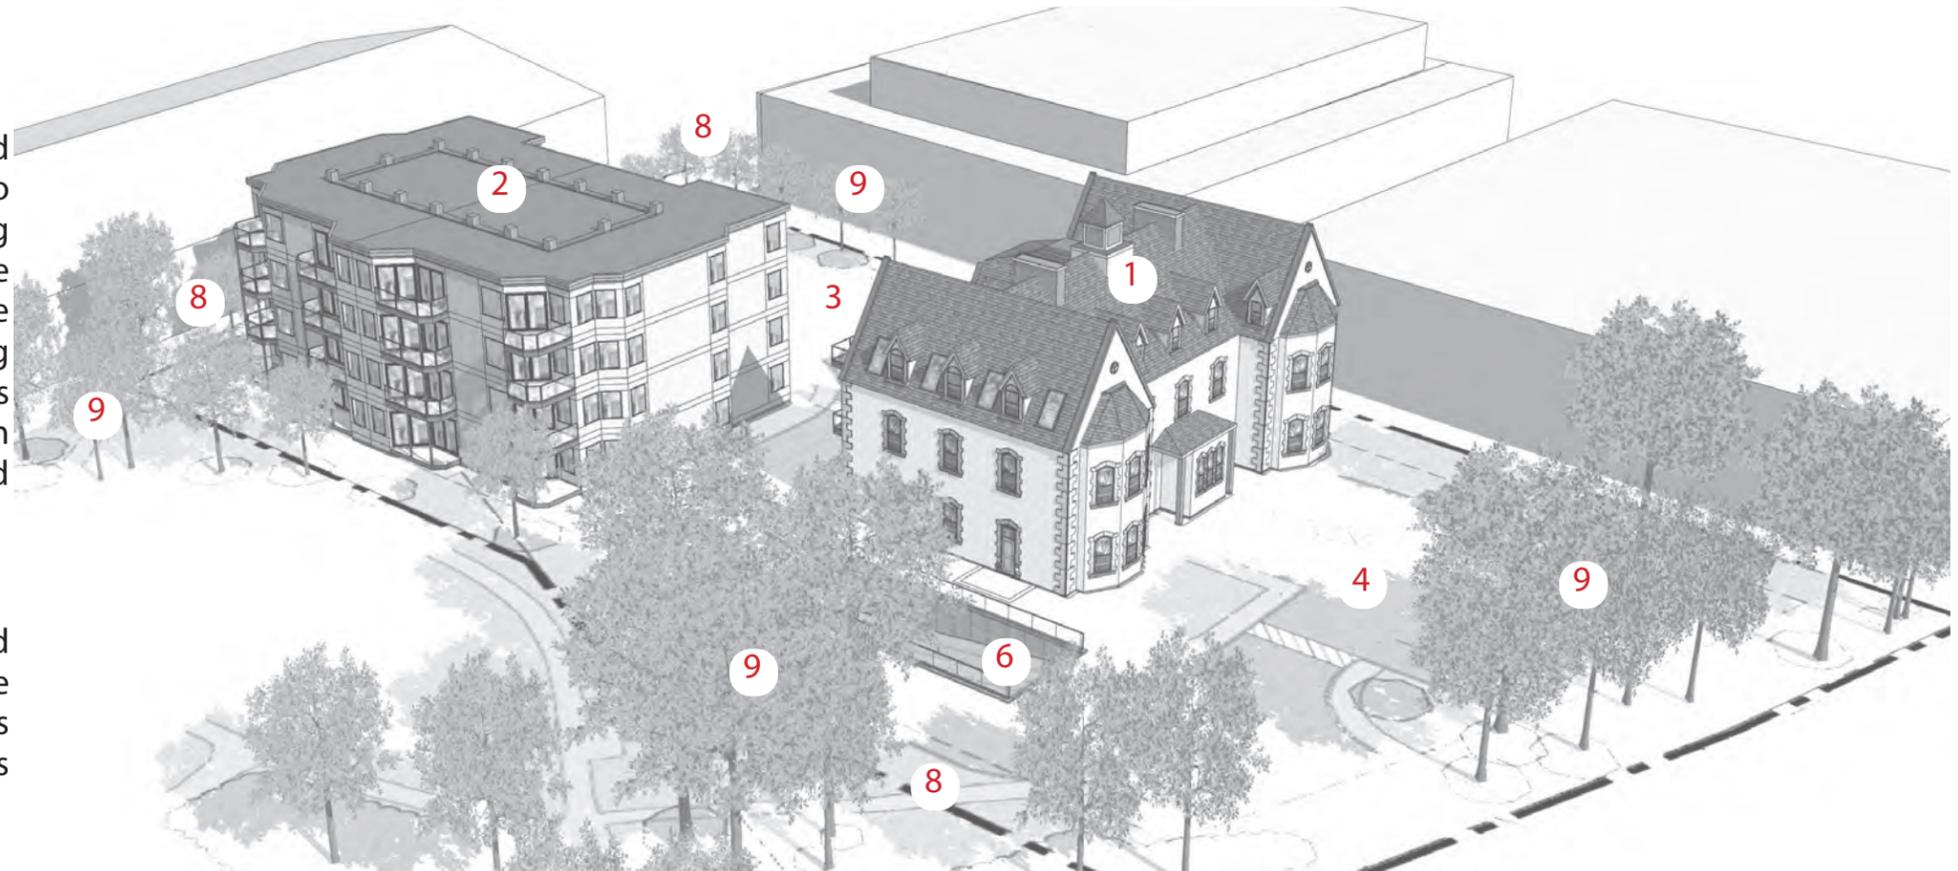
North Elevation - New Building with Monastery behind

1. Parging
2. Sandstone Quions/window trim (repaired)
3. Metal Shingles (slate style)
4. Painted galvanized metal balconies with glass guards
5. Windows - new double hung
6. Windows - fixed and double hung
7. Composite rainscreen cladding (color, texture and pattern to be determined)

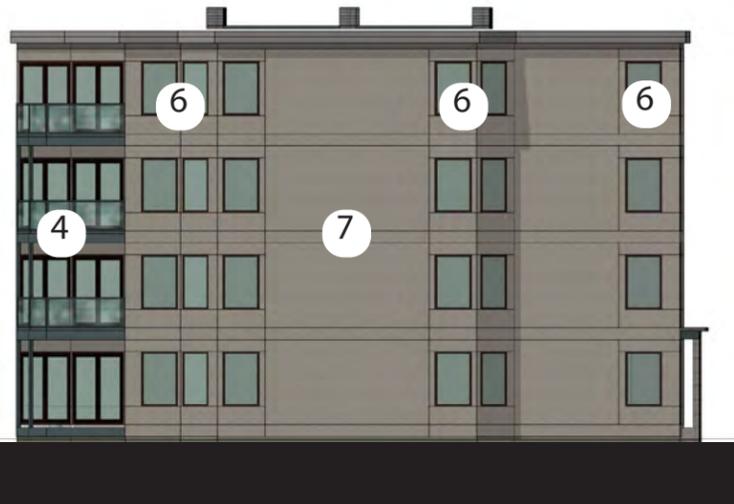
South Elevation - Monastery and New Building

While this door is larger than the other windows, it is designed as part of an organized facade with the balconies and windows below

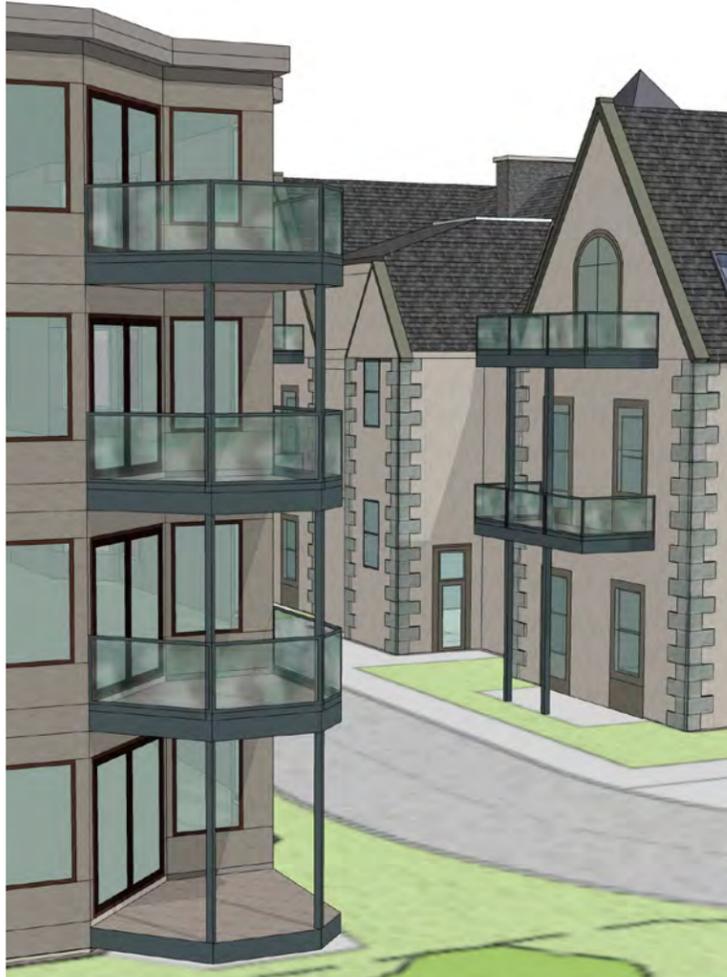
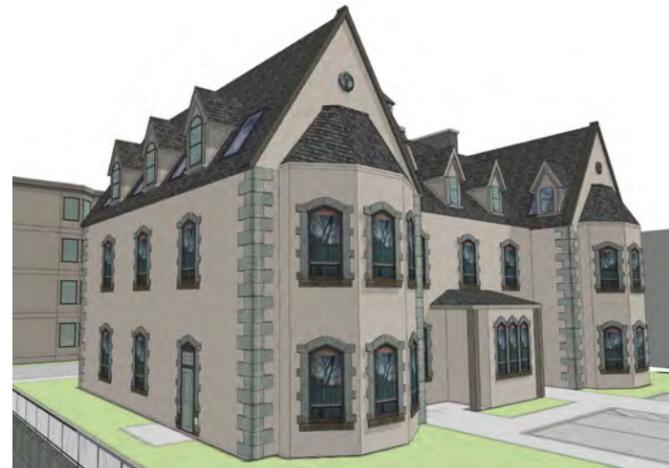
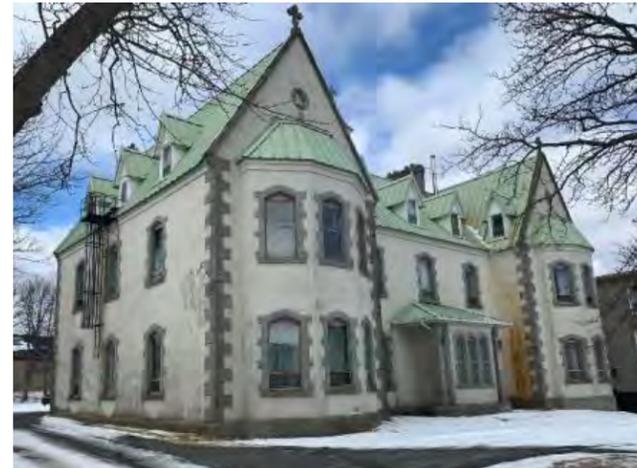
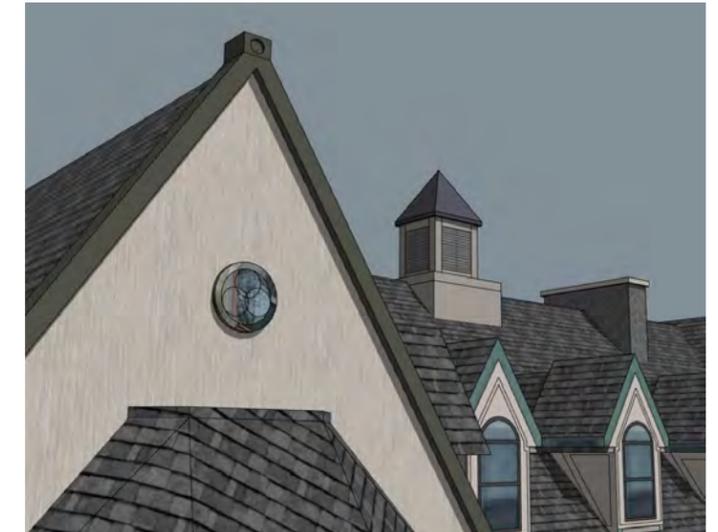
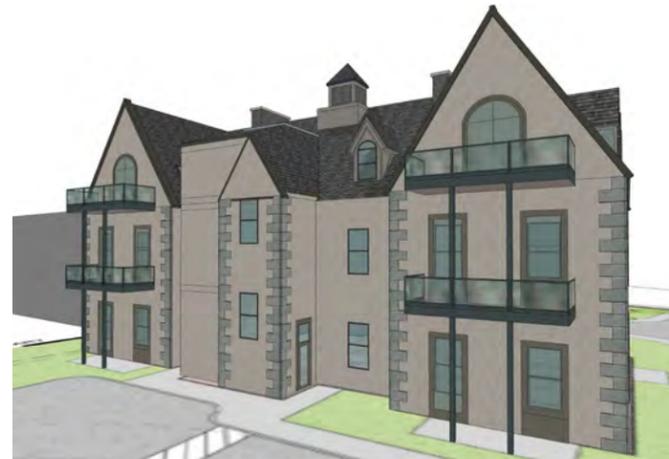
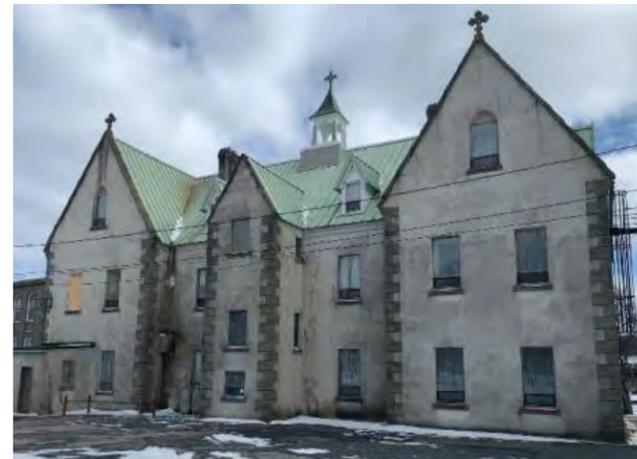
Exterior Features

Rooftop structures

- Cupola
The cupola will enclose 2 intake and exhaust ducts, and several plumbing stacks. It will be approximately the size of the existing. The cupola is not enclosed but the openings are covered with louvers to permit air flow.

It will look similar to the existing with the exception that the cross is removed.

- Finials
The finials are approximately the same size as the existing. There is a simple decorative element and the crosses are removed.
- Chimneys will be repaired

- Walls, repair and new epoxy parged surface similar to existing
- Sandstone Quoins, repair, clean and new epoxy topcoat
- Roof, New Metal shingles.

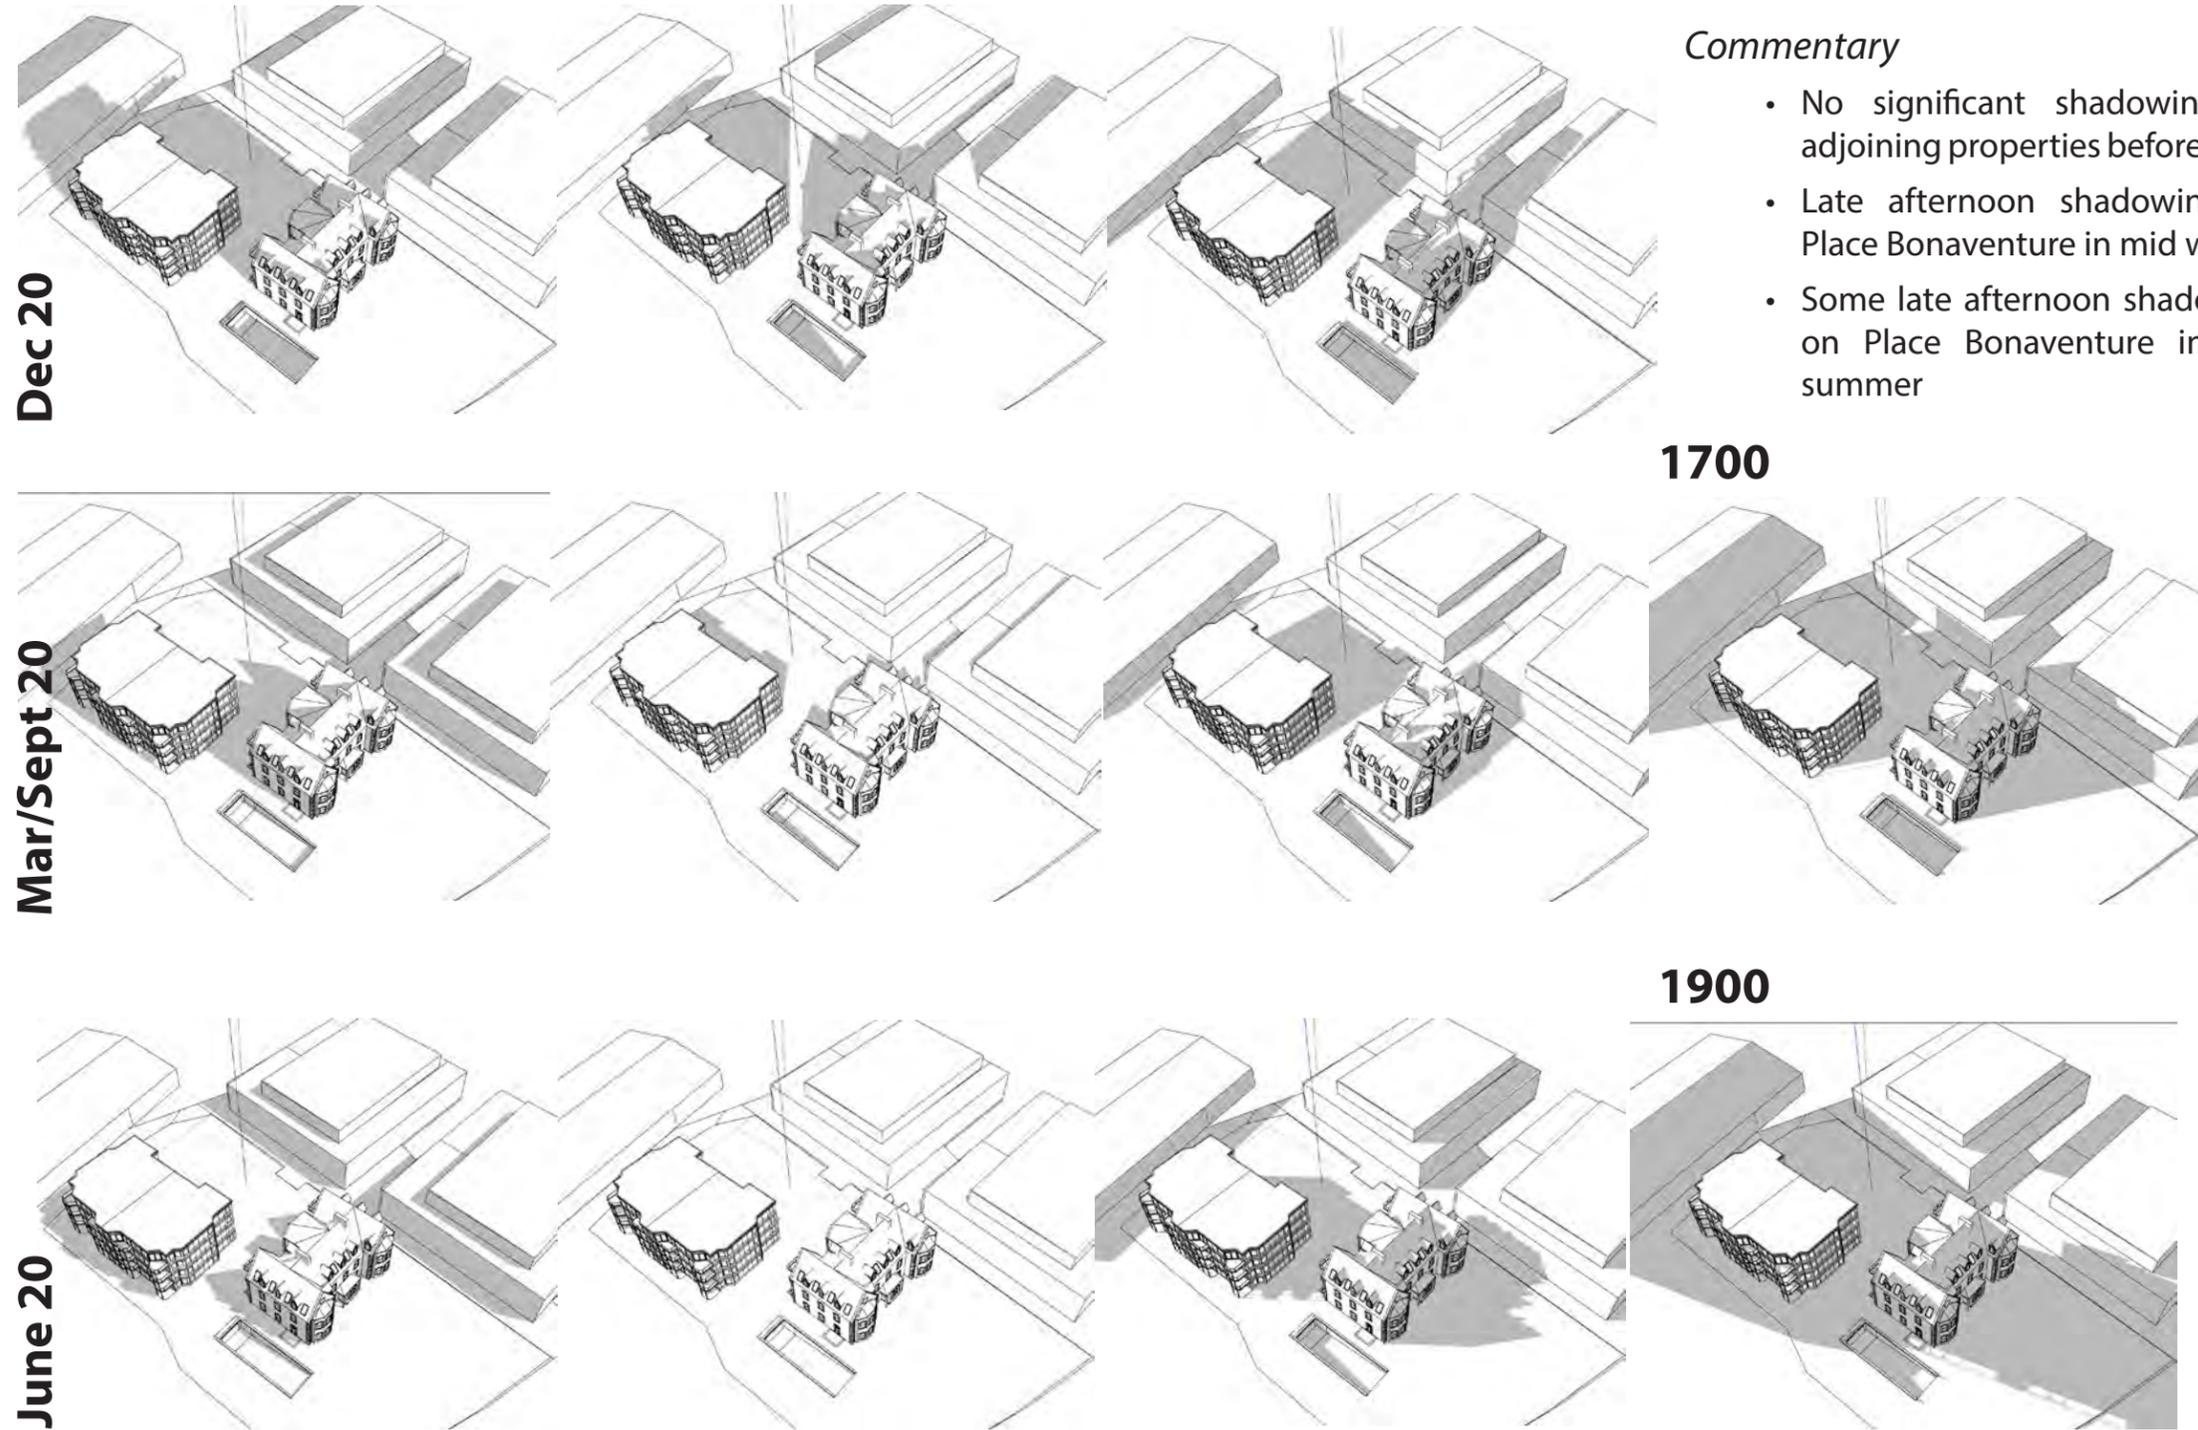
Shadowing

- No significant shadowing on adjoining properties before noon
- Late afternoon shadowing on Place Bonaventure in mid winter
- Some late afternoon shadowing on Place Bonaventure in mid summer

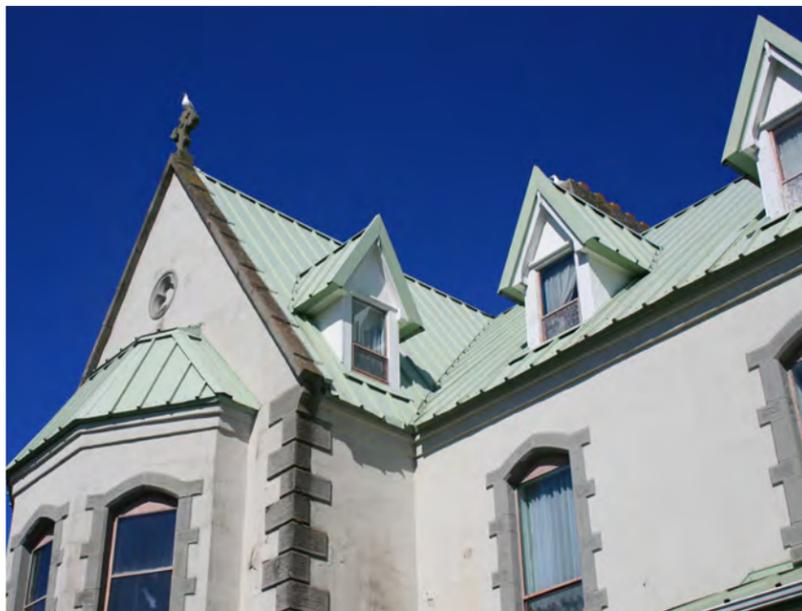
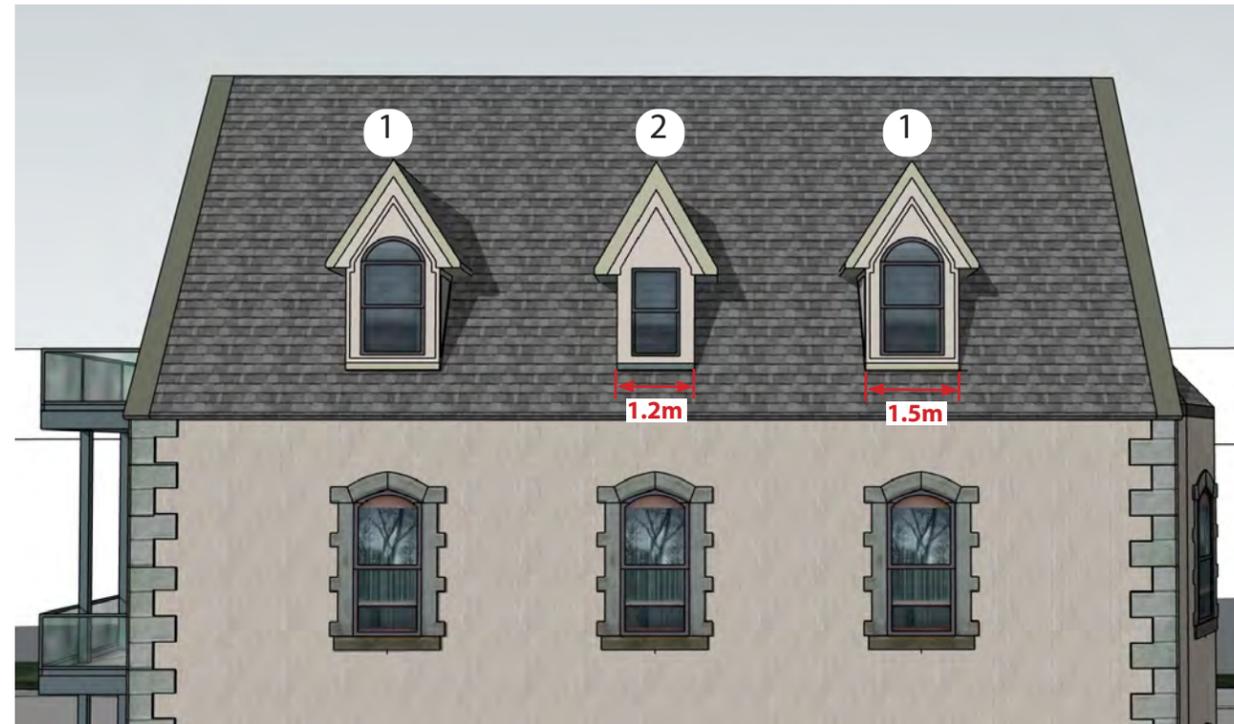
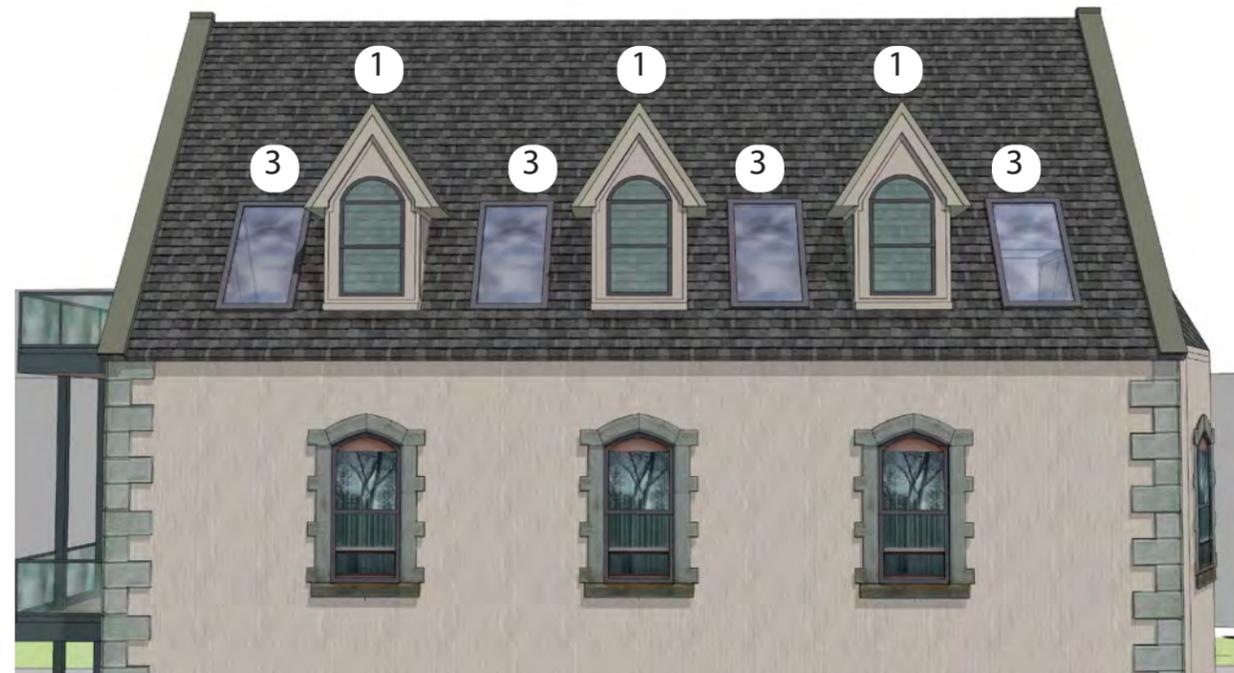
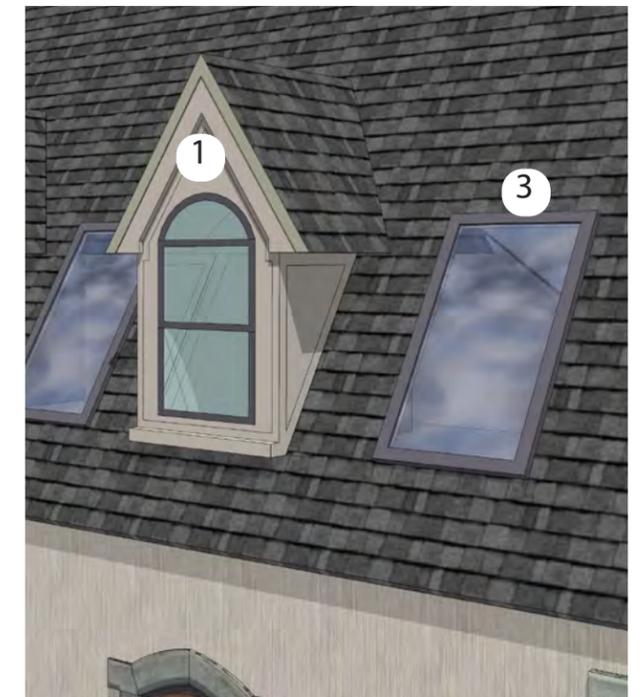
Proposal for Dormers (sides and rear facade only)

1. Increase the size of the dormer so that window width matches windows below.
2. Shows the existing dormer (for reference)
3. Shows skylights in selected locations

The exact placement of any skylights, and redesign of dormers will be influenced strongly by what is revealed when interior demolition and demolition of the metal roof around the existing dormers is completed. The proponent requests the opportunity to revisit this when completed which can include a site visit with the City and the BHEP.

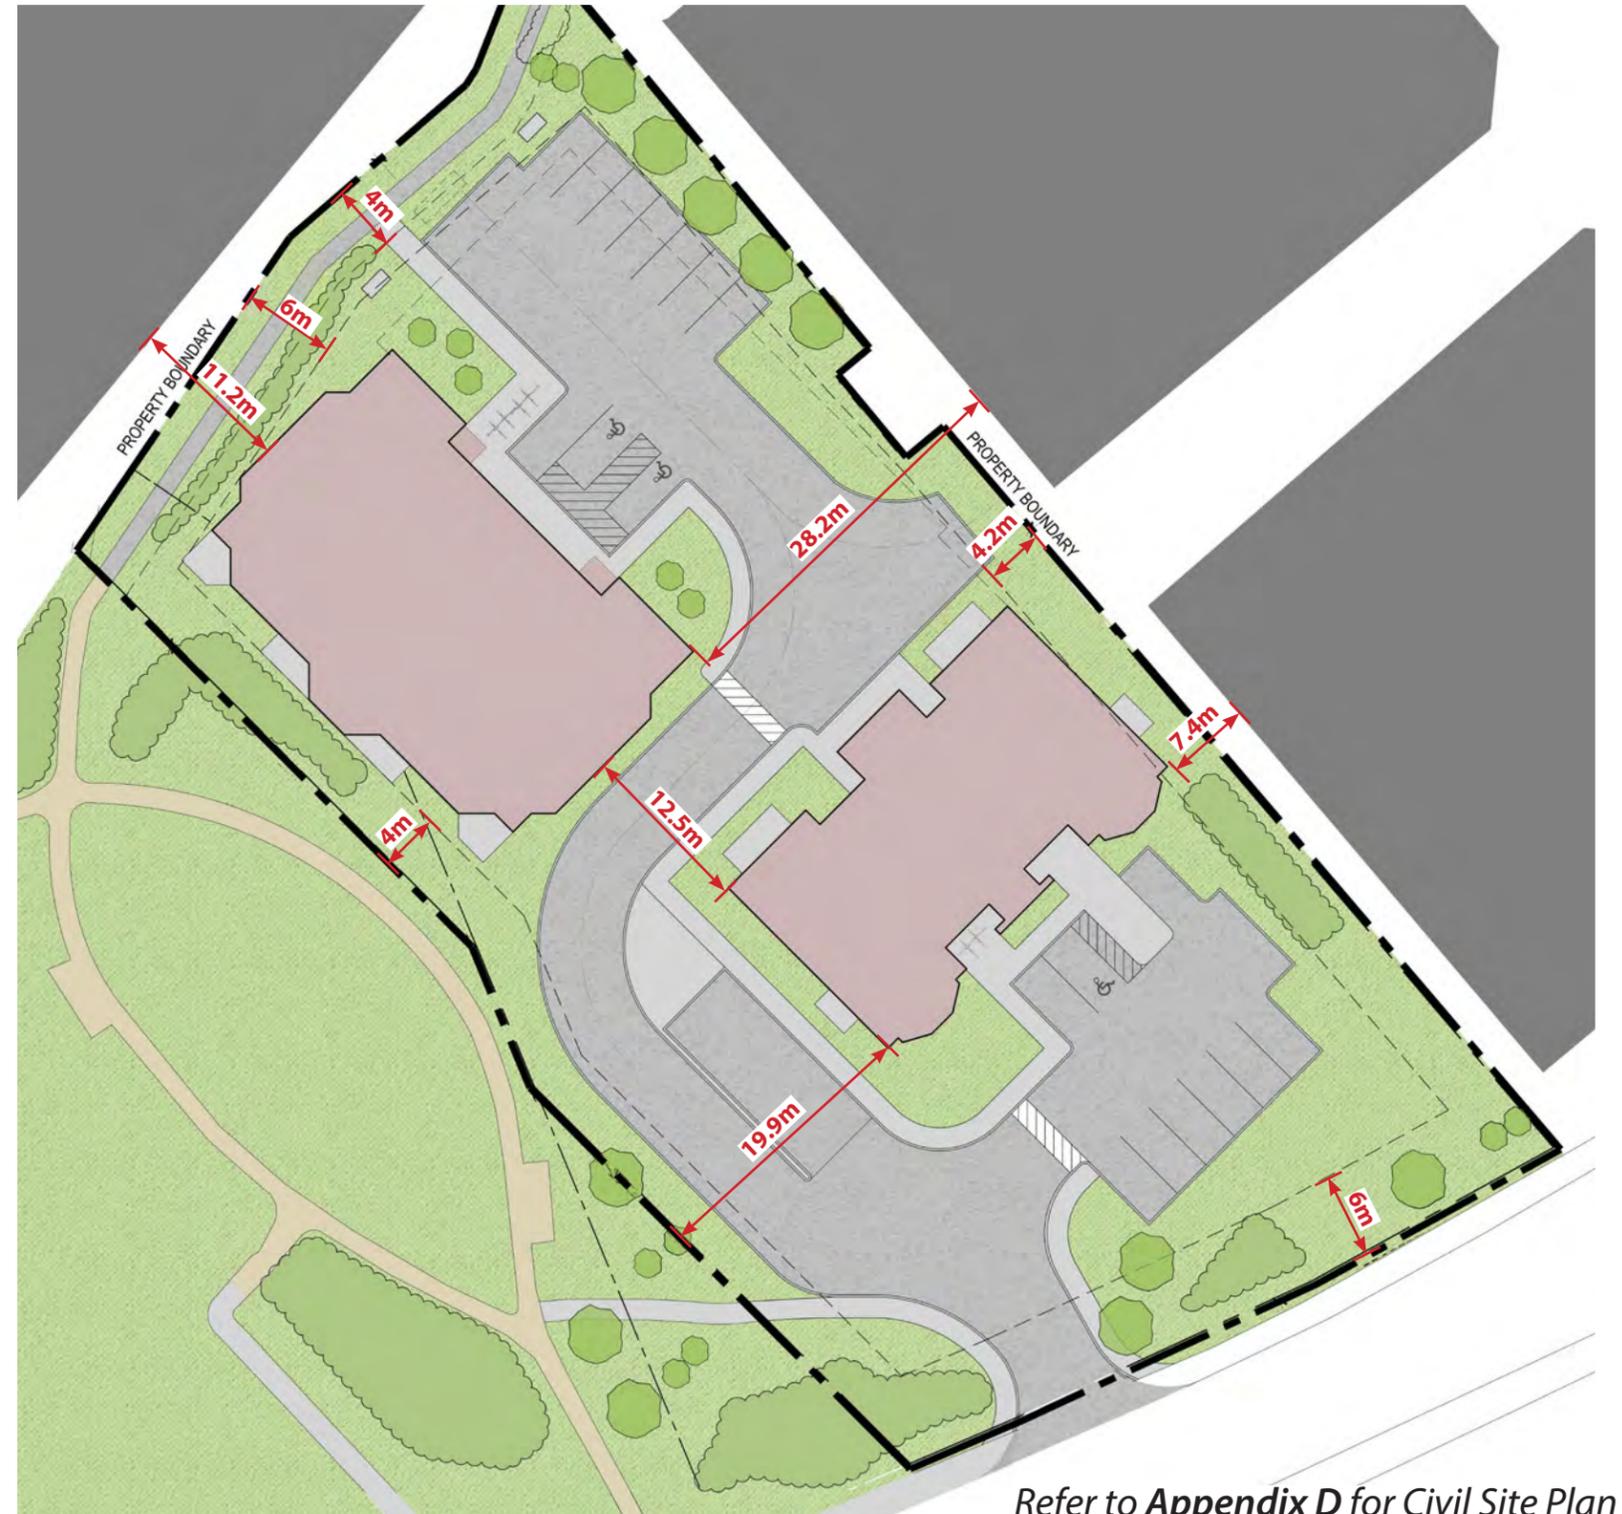
C. Building Location

Note: Western development limits of the property includes the areas of the City approved exchange of land between the City and Emerald Atlantic Group

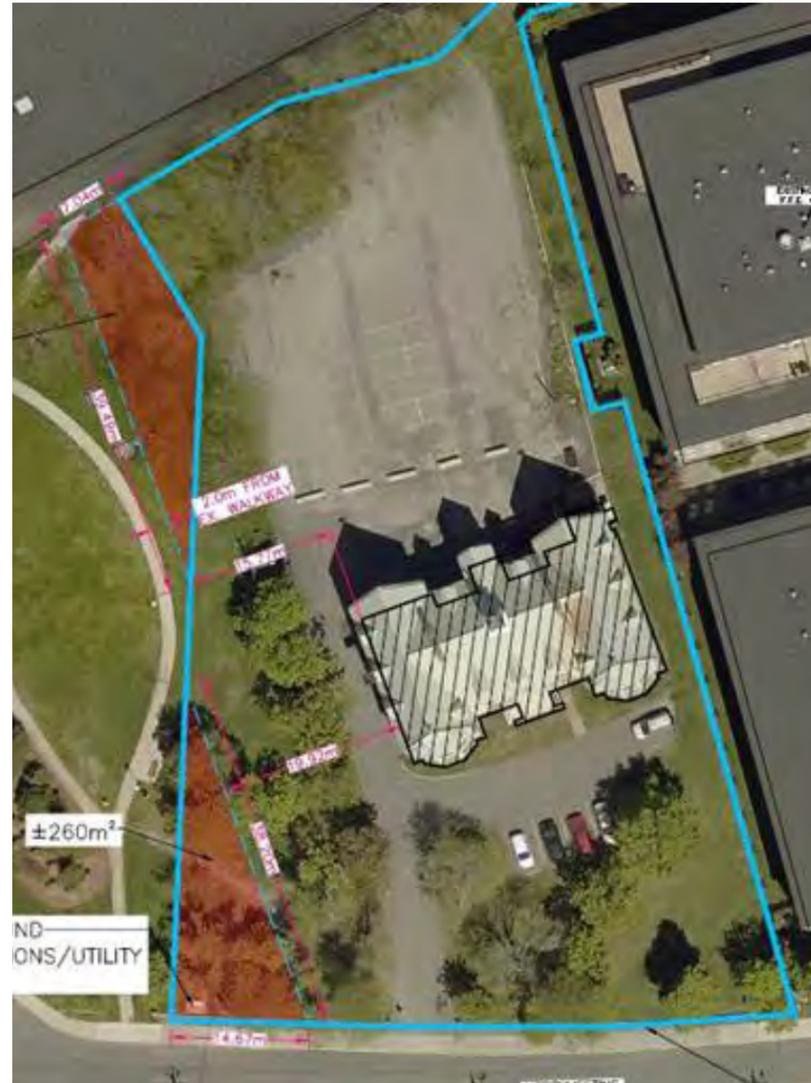
Bonaventure Walkway

The untended path from Bonaventure Avenue to the site will be upgraded to an asphalt walkway, 1.8m wide. The walkway will continue along the north boundary to connect to the existing City paths.

Subject to legal requirements, the proponent will grant a 4m easement to the City for the purpose of City responsibility and maintenance.

The upgraded walkway and connection to the project pedestrian pathways is indicated on the proposed site plan presented in this report.

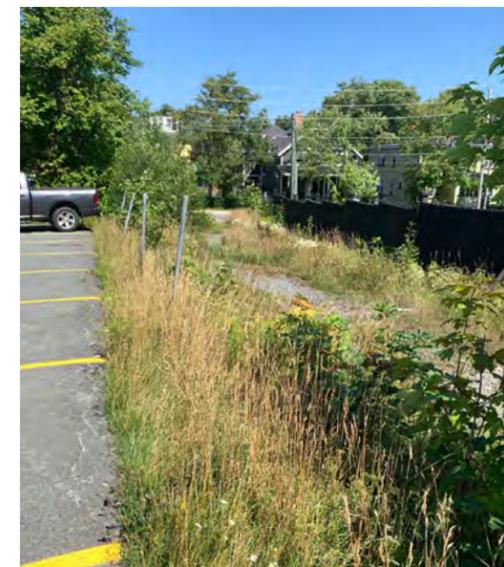
Current condition of path

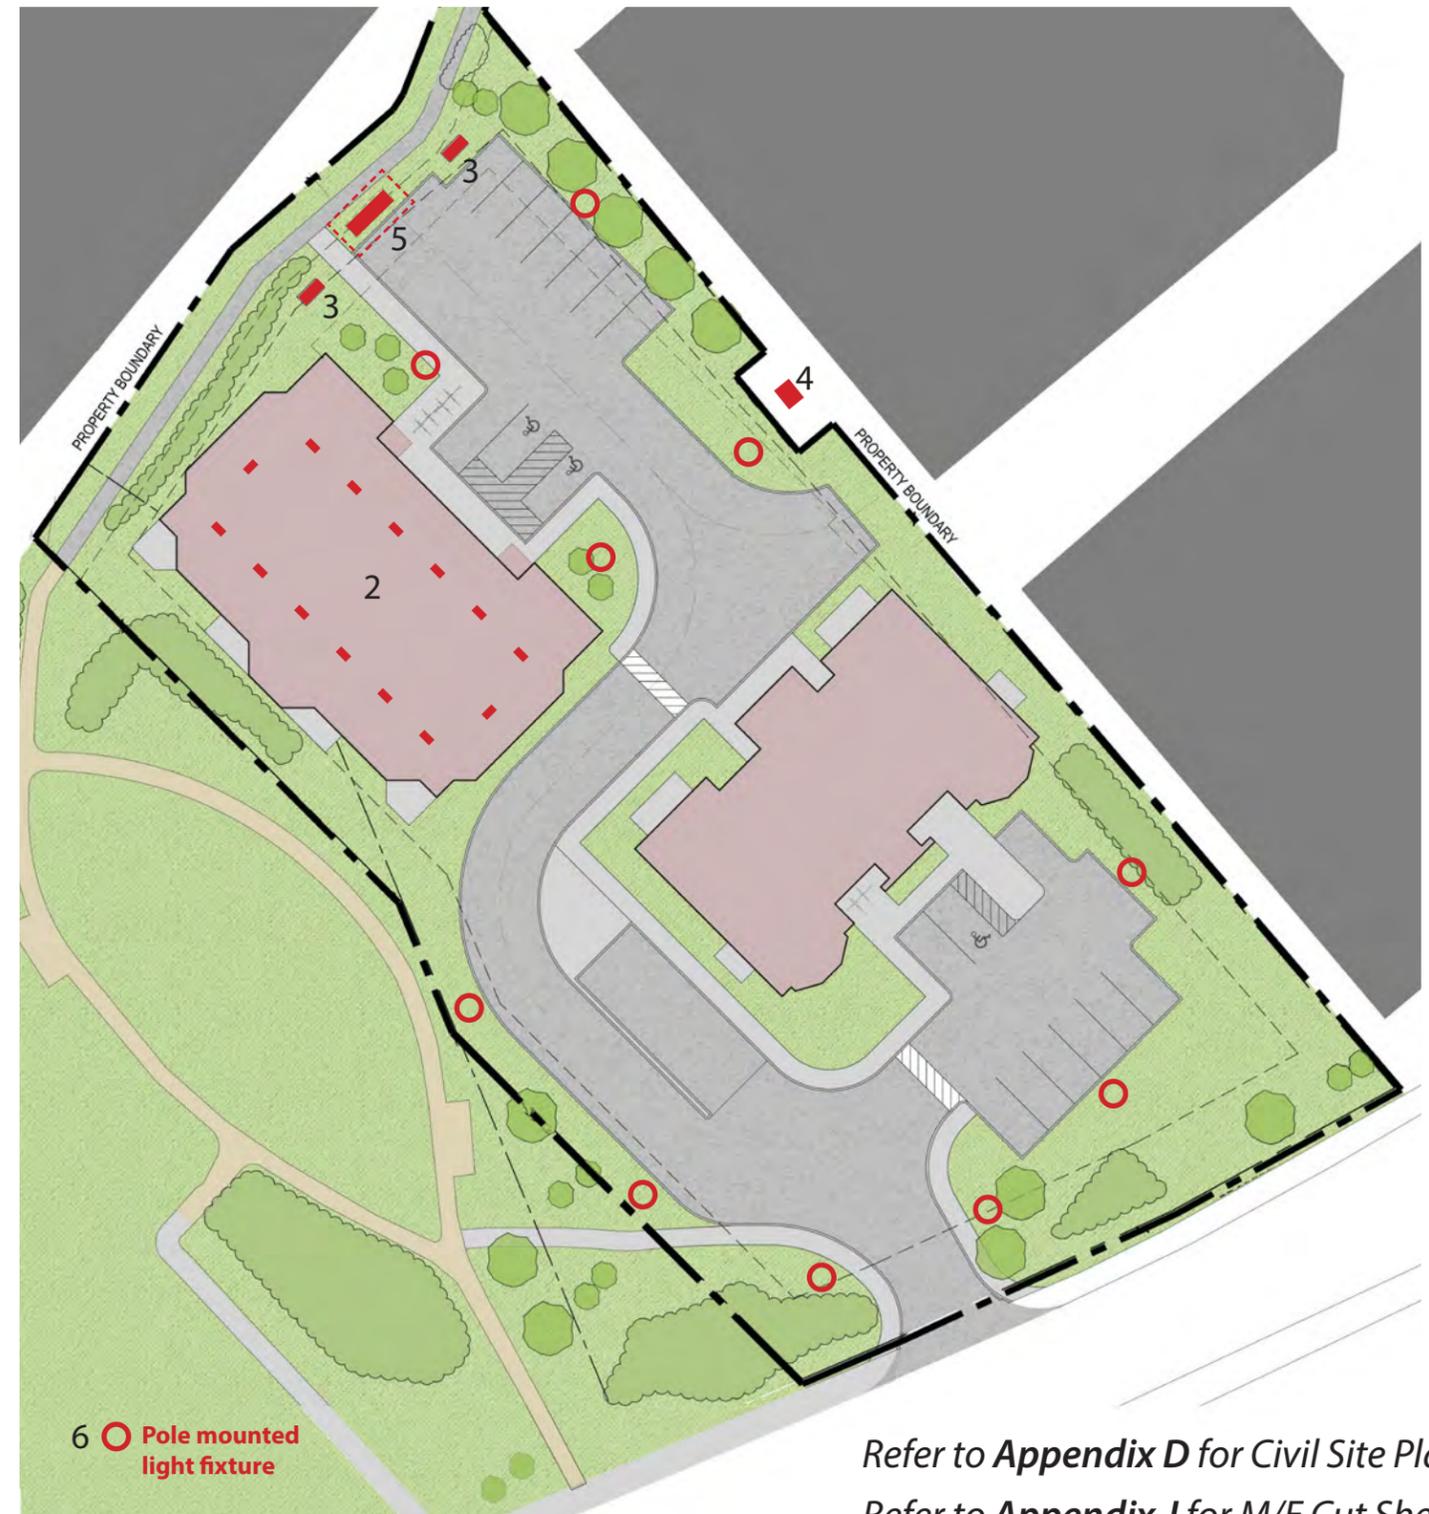
D. Exterior Equipment and Lighting

5. The pad mounted electrical generator will be small and located as indicated. This generator unit will be acoustically insulated, have a built in double walled oil tank, and have the products of combustion directed up and away; consistent with ULC standards.

6. All exterior lighting will be designed with full cut-off optics and housings in order to eliminate upward light pollution. Lighting calculations will be performed to ensure that light trespass from the building does not cross property boundaries, except where required for safety reasons. Light will be allowed to spill over the property boundary at entries, exits, and intersections, in order to keep such high traffic areas safe for residents and neighbors. Exterior lighting will be a combination of building and pole mounted. All poles used to support light fixtures will be checked by a Professional Engineer licensed to practice in this Province as meeting the City's required standards for safety.
