Revised submission Feb 06, 2023

Heritage and Land Use Report

Building and Site Redevelopment - 4 Merrymeeting Road, St. John's, NL

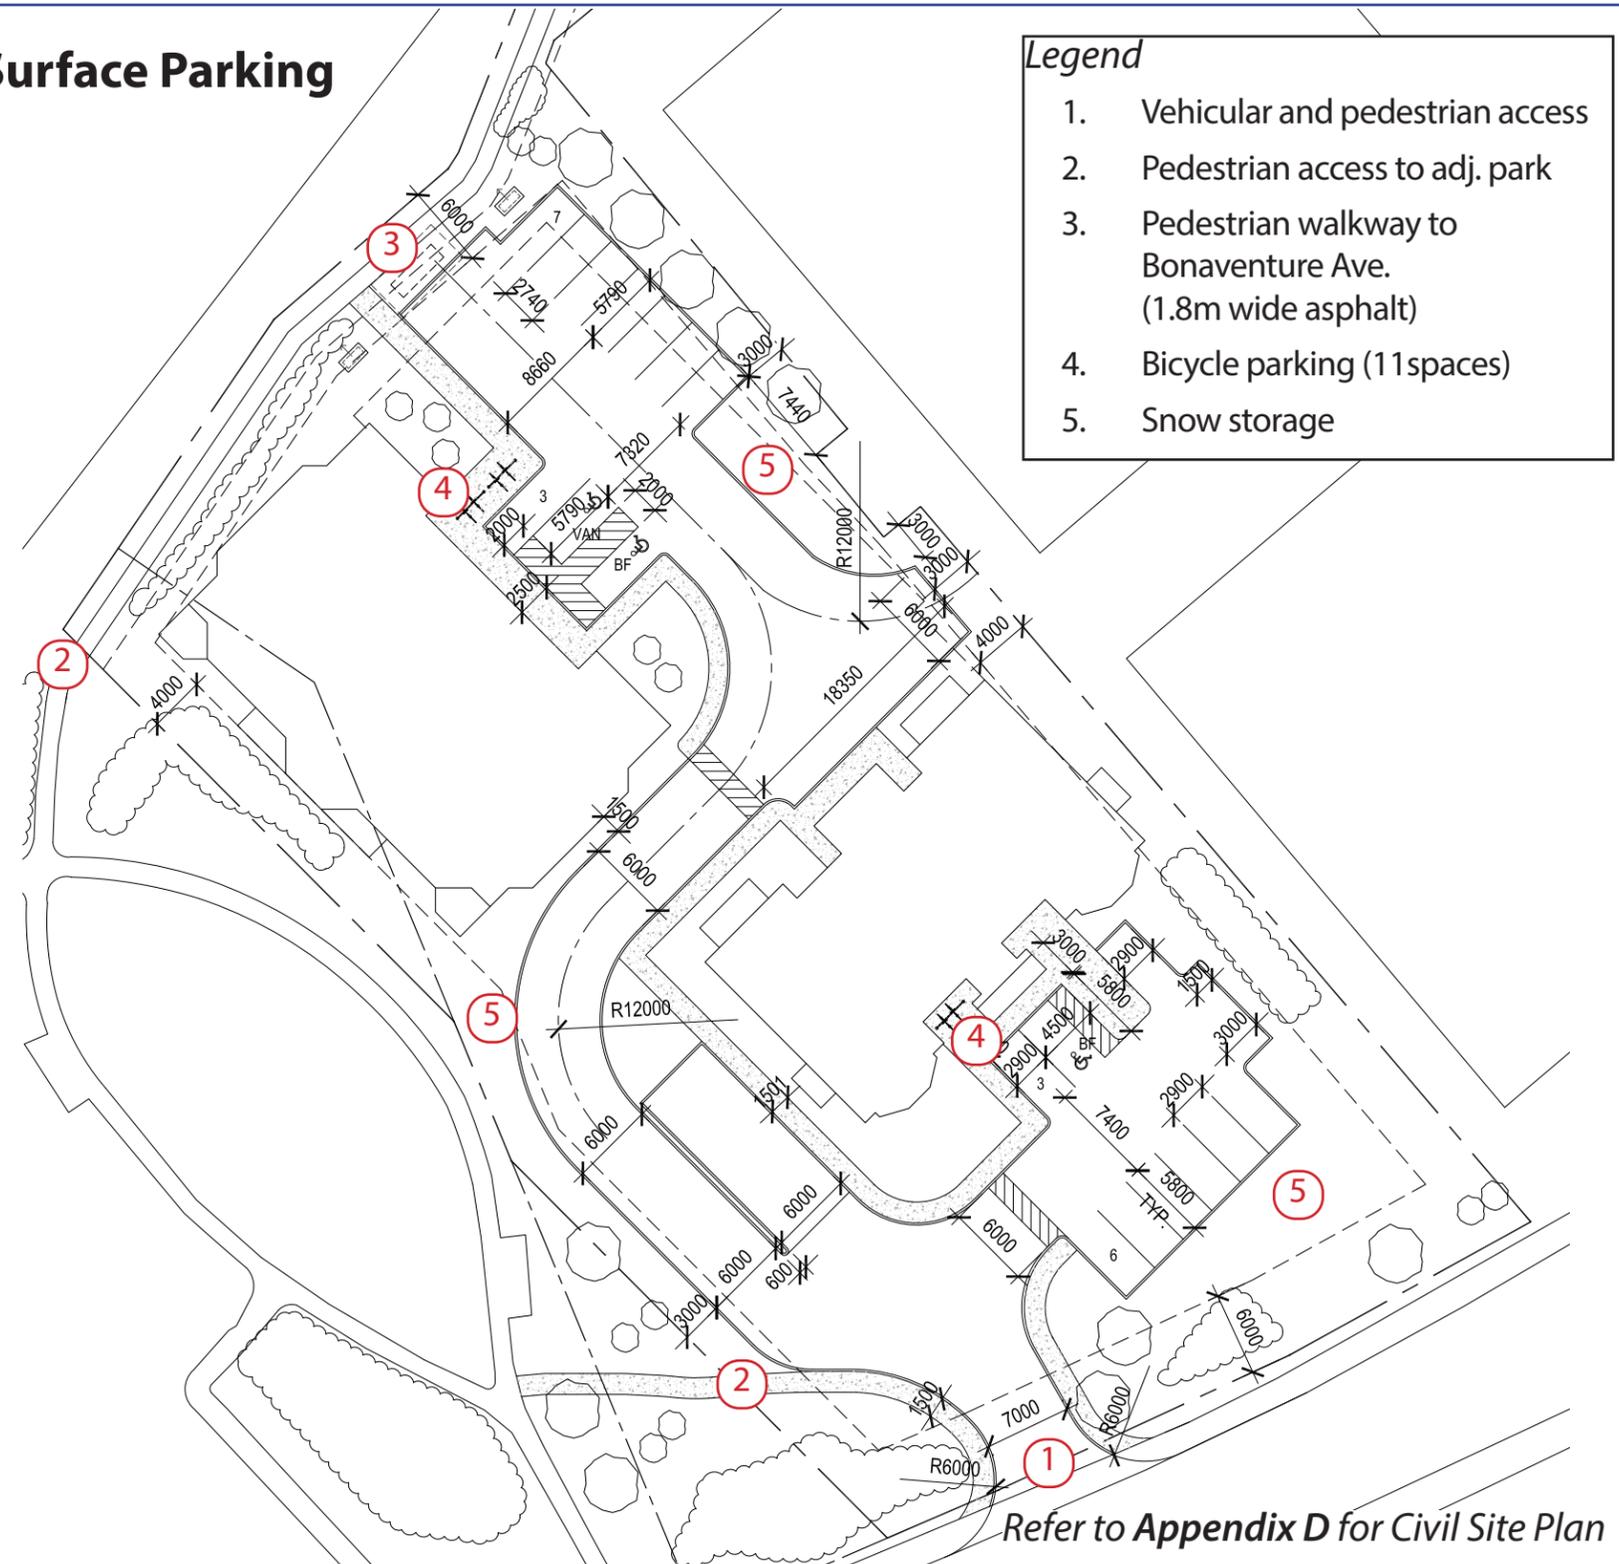
Surface Parking

Our approach is to provide the bulk of the parking underground. Surface spaces allow for over flow, visitor parking and courier parking.

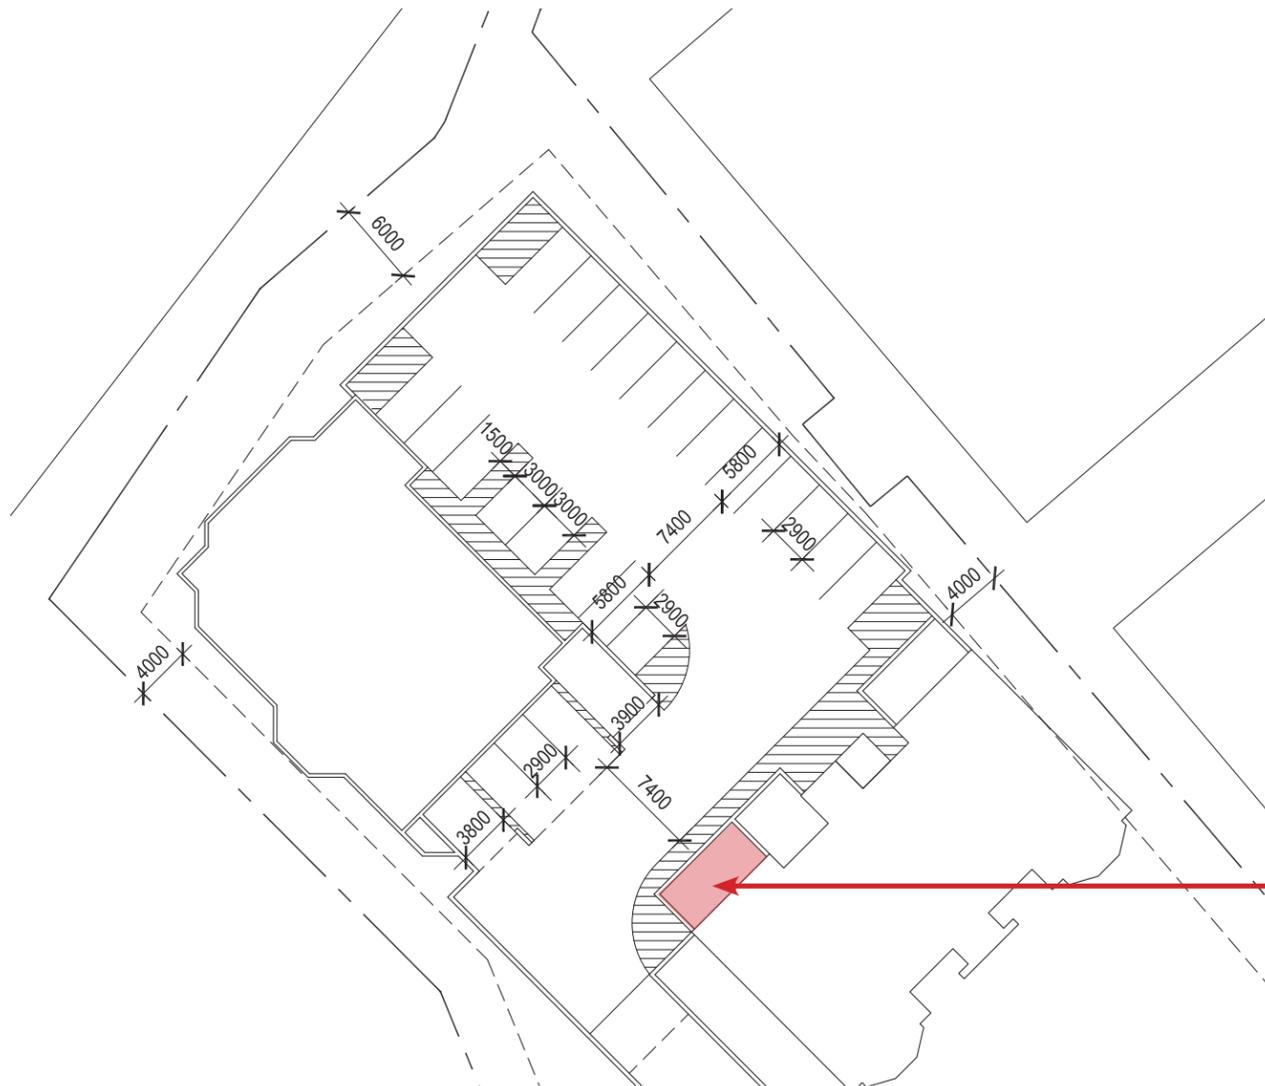
Parking Garage (below grade)

- Resident Parking (covered) 25 Spaces
- Visitor Parking (surface) 19 Spaces
- Total Parking 44 Spaces

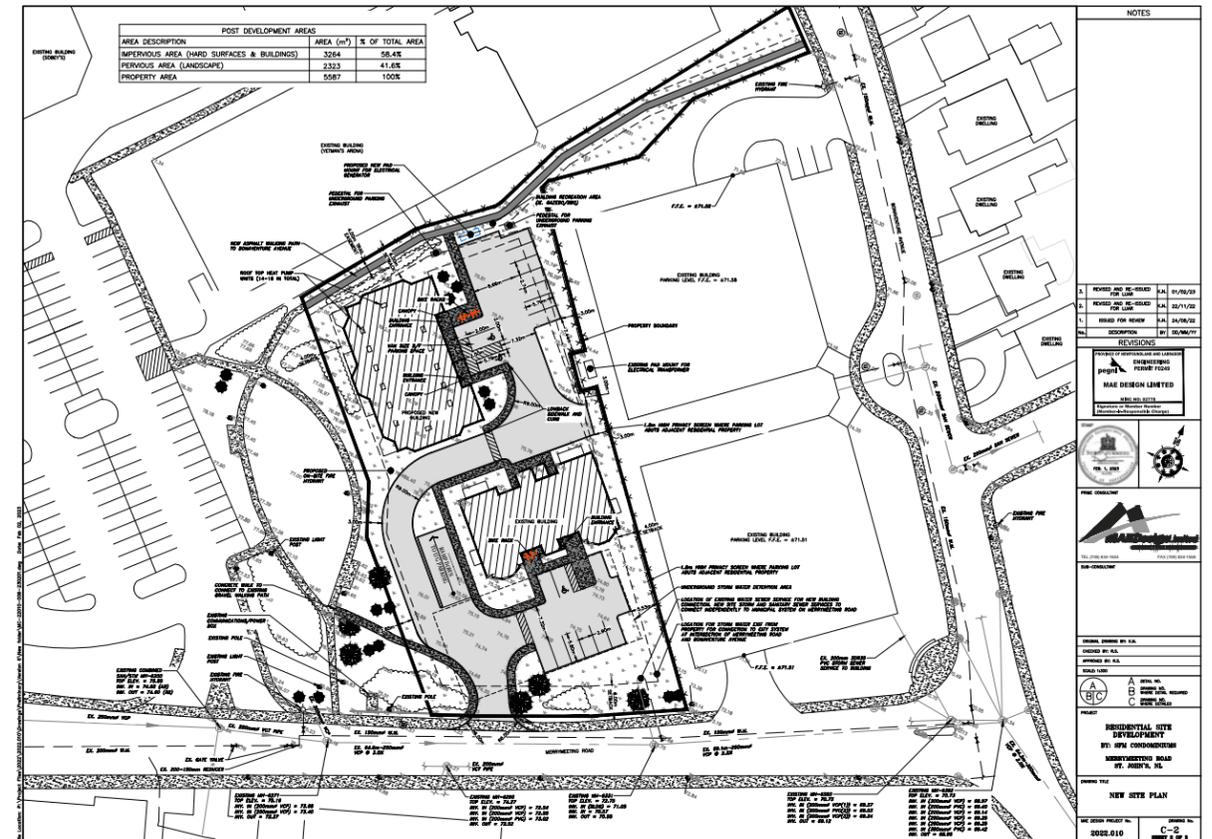
8. A new private fire hose hydrant will be provided on the site as required by the NBCC for fully sprinklered buildings. Refer to the site plan for location. A CSA listed back flow preventer will be provided in a heated space below the new building for the back flow preventer.

9. Each building will have new separate fire and domestic water mains. The proposed locations and sizes are indicated on the site plan. Each of these water mains will have individual prevention to CSJ requirements. The dry automatic sprinkler system for the parking structure will be serviced from the new building.
